INDOOR AIR QUALITY ASSESSMENT

**Department of Developmental Services
100 Cummings Center
Beverly, Massachusetts**

Prepared by:
Massachusetts Department of Public Health
Bureau of Environmental Health
Indoor Air Quality Program
January 2019

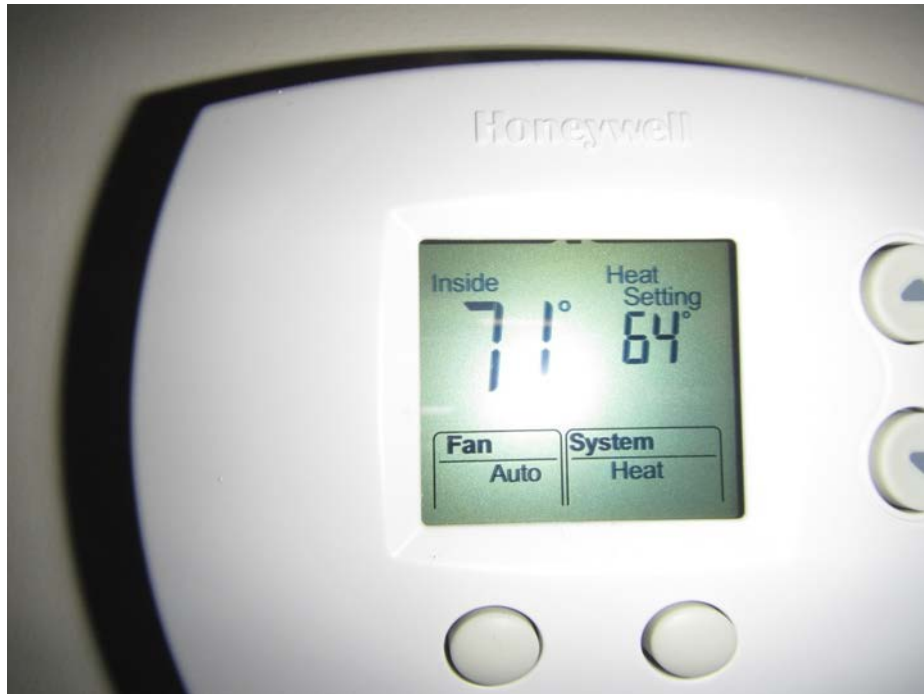
Picture 1

Some thermostats were set to “Fan Auto” (Picture 1). The thermostat fan settings for the AHUs should be inspected to ensure they are set to “Fan On” rather than “Auto”. This is especially important during temperate weather in spring and fall where heating or cooling may not be called for frequently. Intermittent fresh air supply will likely increase occupant complaints regarding IAQ.

Thermostat showing Fan setting of “Auto” rather than recommended “On”

1. Operate the HVAC system to provide for continuous fresh air ventilation during occupied hours. Inspect all thermostats to ensure that they are set for “Fan On” instead of the “Auto” setting.
2. Reduce or eliminate the use of scented cleaners, hand sanitizers, and personal air fresheners.
3. Regularly vacuum carpeting with a HEPA-filtered vacuum cleaner. Clean carpeting at least once per year according to IICRC recommendations (IICRC, 2012).
4. Reduce the amount of accumulated items on surfaces or floors to ensure regular wet-wiping of surfaces and access for custodial staff to HEPA vacuum daily.

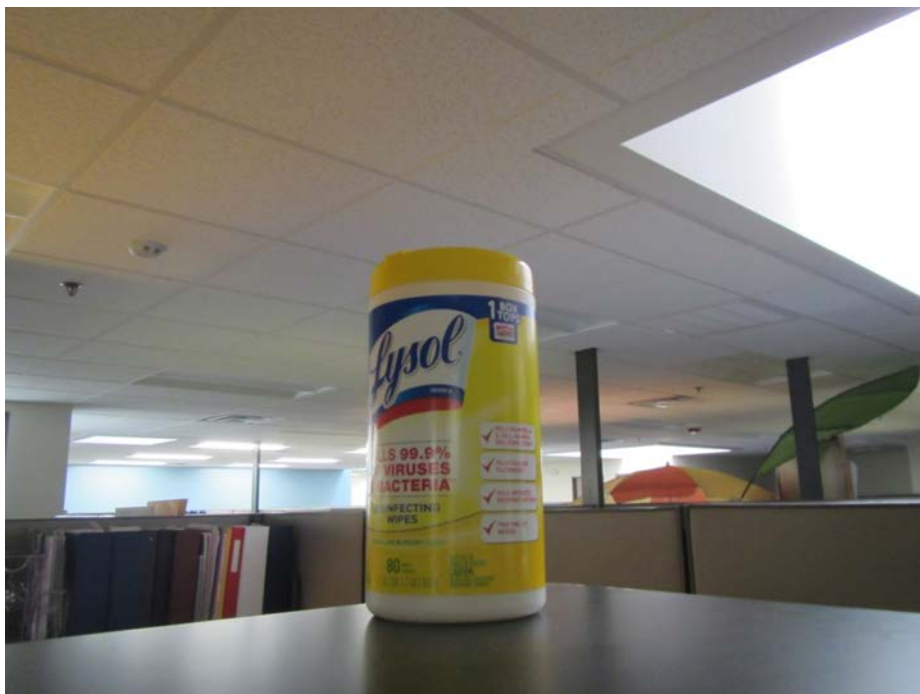
Picture 2

Hand sanitizers, scented cleaning products, and air fresheners were noted in some areas of the office space. These products can cause irritation of the eyes, nose, and respiratory system of some people (Picture 2).

VOC containing cleaners used in occupied areas

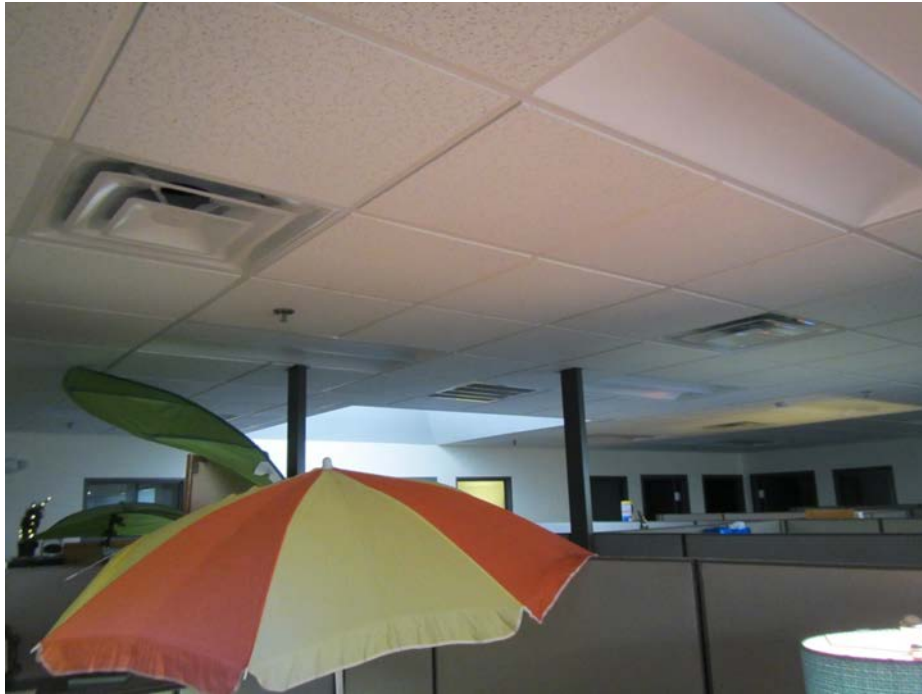
Picture 3

DDS staff reported that a large number of occupants expressed complaints (e.g., eye strain, headaches) due to the new LED lighting fixtures. These occupants reported that the lights are too bright and some occupants have been disabling the lights or using shading techniques such as beach umbrellas to lessen the effects (Picture 3).

LED lights deactivated with umbrellas/various shades in use

6. Investigate methods to alleviate symptoms of those affected by the new lighting fixtures (e.g., the use of dimmers or blue light filters).
7. If complaints arise from occupants in offices with supply only ventilation, consider installing passive vents in the door or wall until permanent return vents can be installed. Otherwise, encourage the use of open doors in these areas when privacy is not needed.
